# 2008 Annual Report

## *Mower County*

### *Drainage Systems*

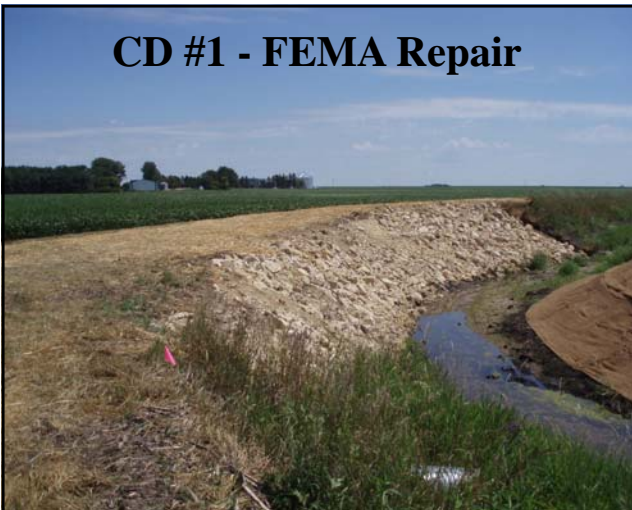
**CD #1 - FEMA Repair**

- PAST/FUTURE REPAIRS:** The one rod grass strip is now established along side the open ditch. There were four different tile repairs this past year. We will continue a spraying program every year for the first few years to make sure we have the trees and brush under control. A heavy rain in the month of June created some heavy damage on this system. The repair bill for repairing this was \$25,850.00 of which FEMA paid 90%.

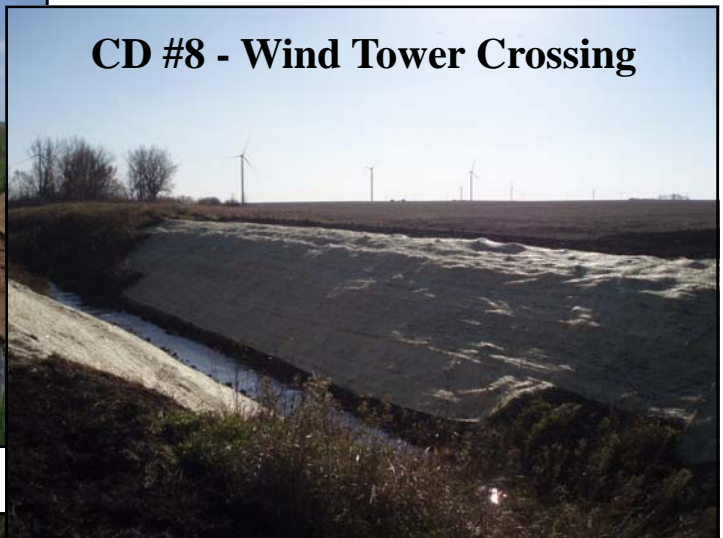
**CD #8 - Wind Tower Crossing**

- PAST/FUTURE REPAIRS:**  
Past repairs consisted of removal of beaver dam and repair of the open ditch banks due to flood damage. We have installed flood water control pipes in strategic locations to lessen bank damage and we now have a tree/shrub spraying program to keep beavers out of the ditch. We also have done minor cleanouts in areas that silted in due to heavy runoff from the surrounding fields. There are now CRP filter strips along side most of the open ditch to prevent silting in the future.

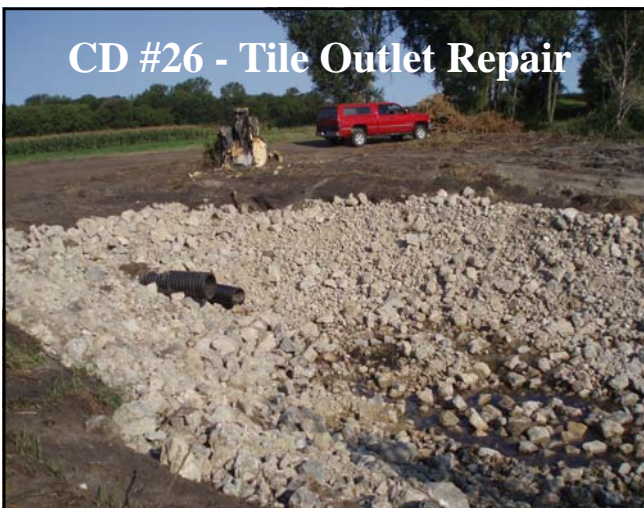
**CD #26 - Tile Outlet Repair**

In 1953 a repair petition was filed and the open ditch was cleaned and two structures repaired. There was also a major cleanout done in the mid 1980's and a repair to the main tile in 1999 due to heavy flooding that year. The cleanout of the open ditch was started in 2007 and finished in January of 2008. In June, 2008, there were heavy rains that caused extensive damage to a few areas of the open ditch. FEMA paid for 90% of the repair bill which amounted to \$12,152.00. In 2009, the open ditch will be sprayed to control the brush and trees.

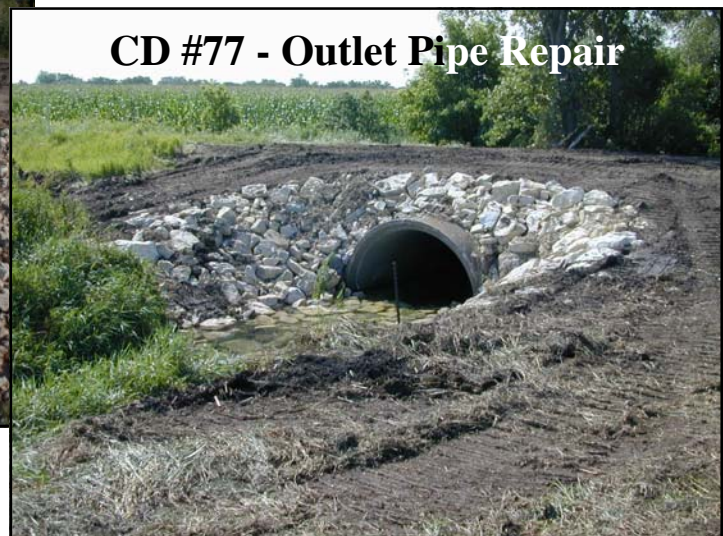
**CD #77 - Outlet Pipe Repair**

A major cleanout of the open ditch was done in 1996. There has been minor tile repairs over the years. A maintenance program of spraying for trees/shrubs helps keep this system in very good condition.
